National Transportation Safety Board Aviation Accident Final Report

Location:	Juneau, AK	Accident Number:	ANC15FA049
Date & Time:	07/17/2015, 1318 AKD	Registration:	N62AK
Aircraft:	CESSNA 207A	Aircraft Damage:	Substantial
Defining Event:	Controlled flight into terr/obj (CFIT)	Injuries:	1 Fatal, 4 Serious
Flight Conducted Under:	Part 135: Air Taxi & Commuter - Scheduled

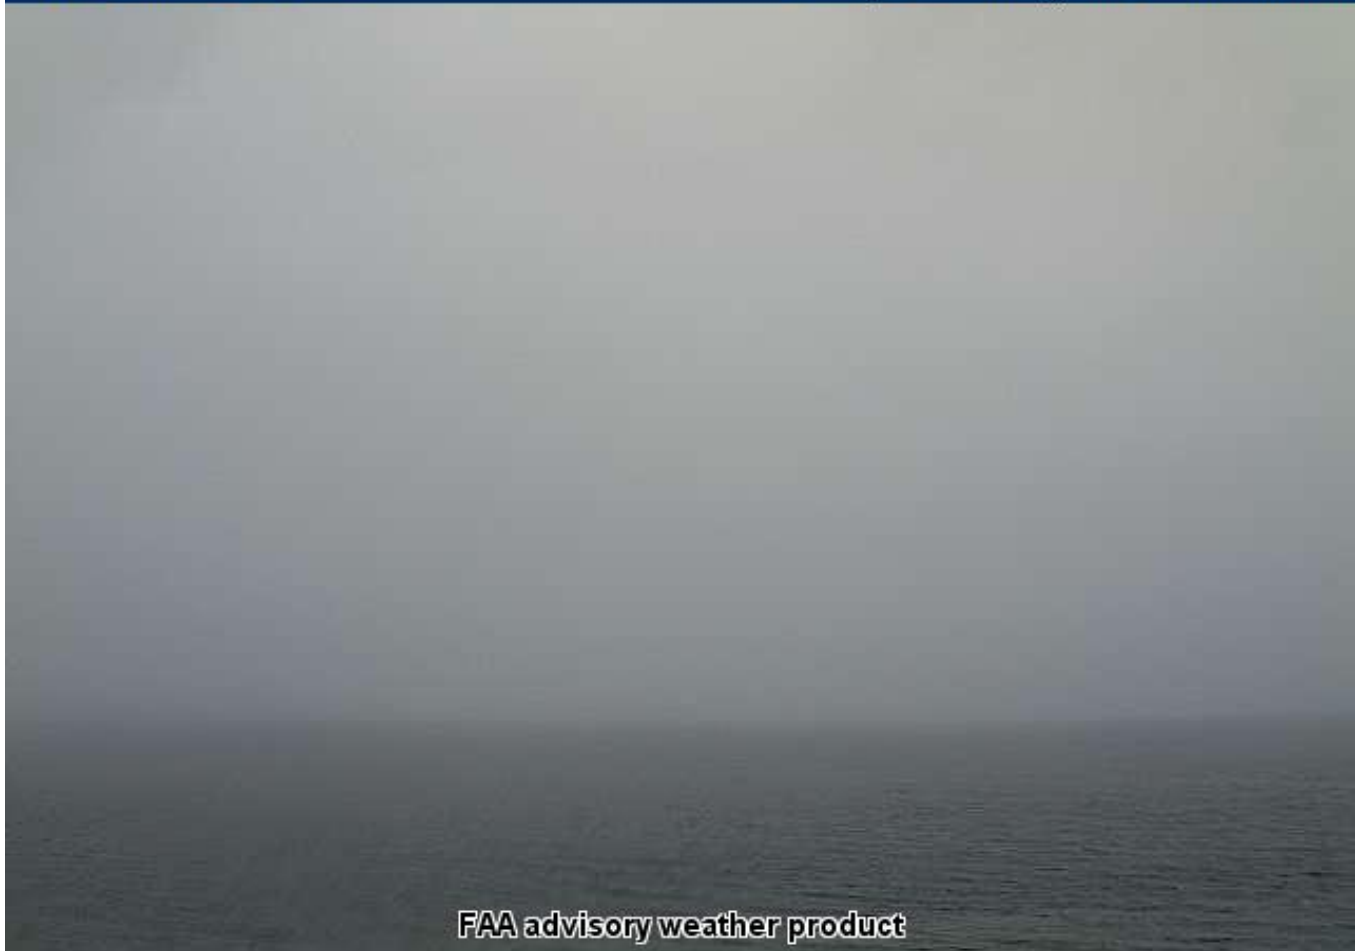
Sisters Island - NorthEast
See <http://avcams.faa.gov> for more information

Numerous Federal Aviation Administration (FAA) weather cameras are located in the vicinity of the Juneau Airport. Images from several of the cameras closest to the pilot's flight route were obtained for the period from 1100 to 1600 on the day of the accident. Figure 1 shows an image that was taken about 5 minutes before the estimated accident time, facing the direction of the accident location. (Refer to the Meteorology Group Chairman's Factual Report in the public docket for further weather information and weather camera images.)

Figure. A video camera image showing visibility conditions at Juneau Airport about 5 minutes before the estimated accident time, facing the direction of the accident location.
